CONSTRUCTED
TO LAST

**WASTEWATER
DIGEST.**

**Informed considerations for generational
wastewater system construction**

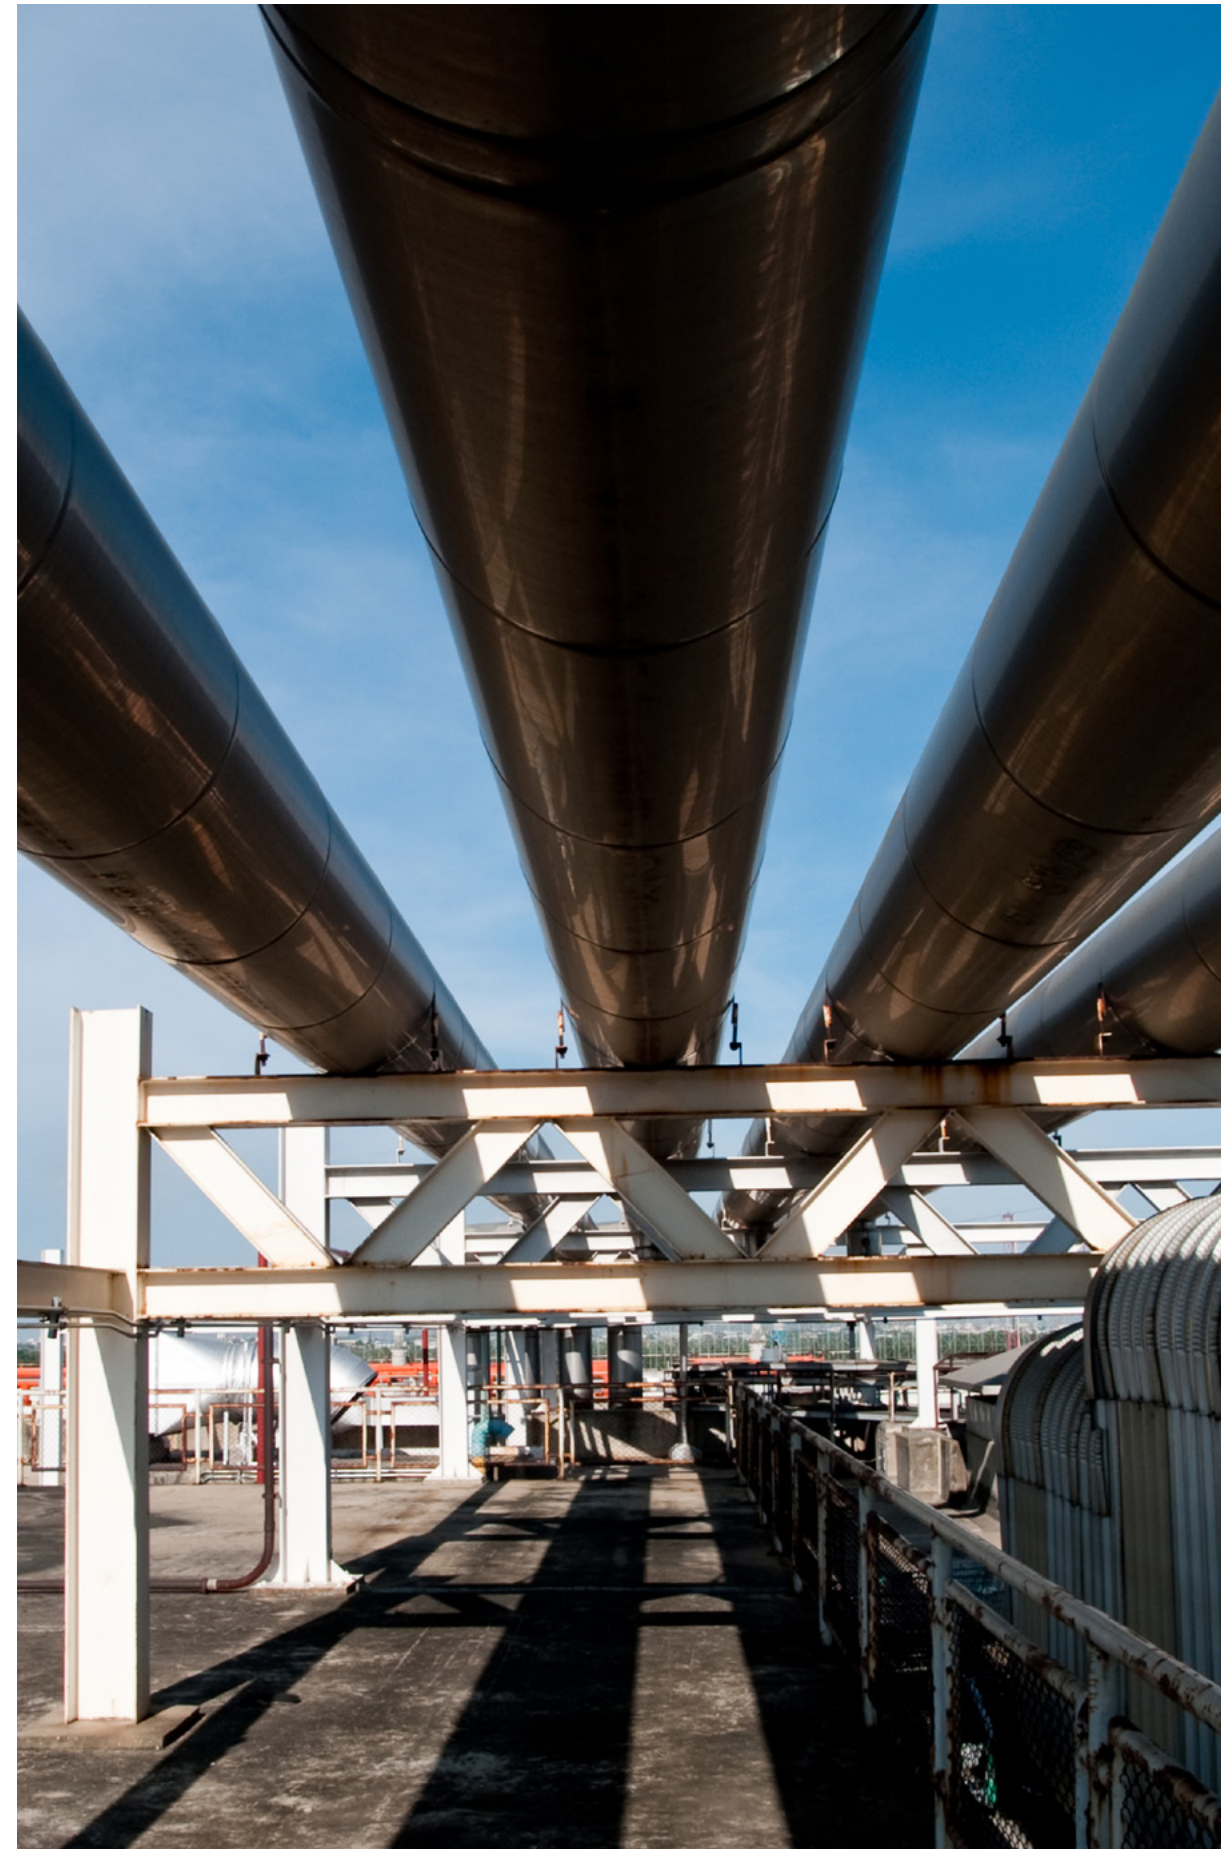
The Champion Strut system can be used as a Champion Duct conduit support system which is customizable with multiple channel profiles and parts to fit all types (GRC, PVC, etc.) of conduit installations. The system includes wall mounts, trapeze hanging systems and column loading supports for versatility in constructing conduit and piping support in projects.

Champion Strut is lightweight and can be easily cut and drilled to fit project specifications at the job site. Once installed, accessories such as pipe clamps, piping hangers and clevis hangers that hold and stabilize the conduit are inserted or attached to the strut channel. Contractors typically find that installation with Champion Strut moves swiftly and seamlessly.

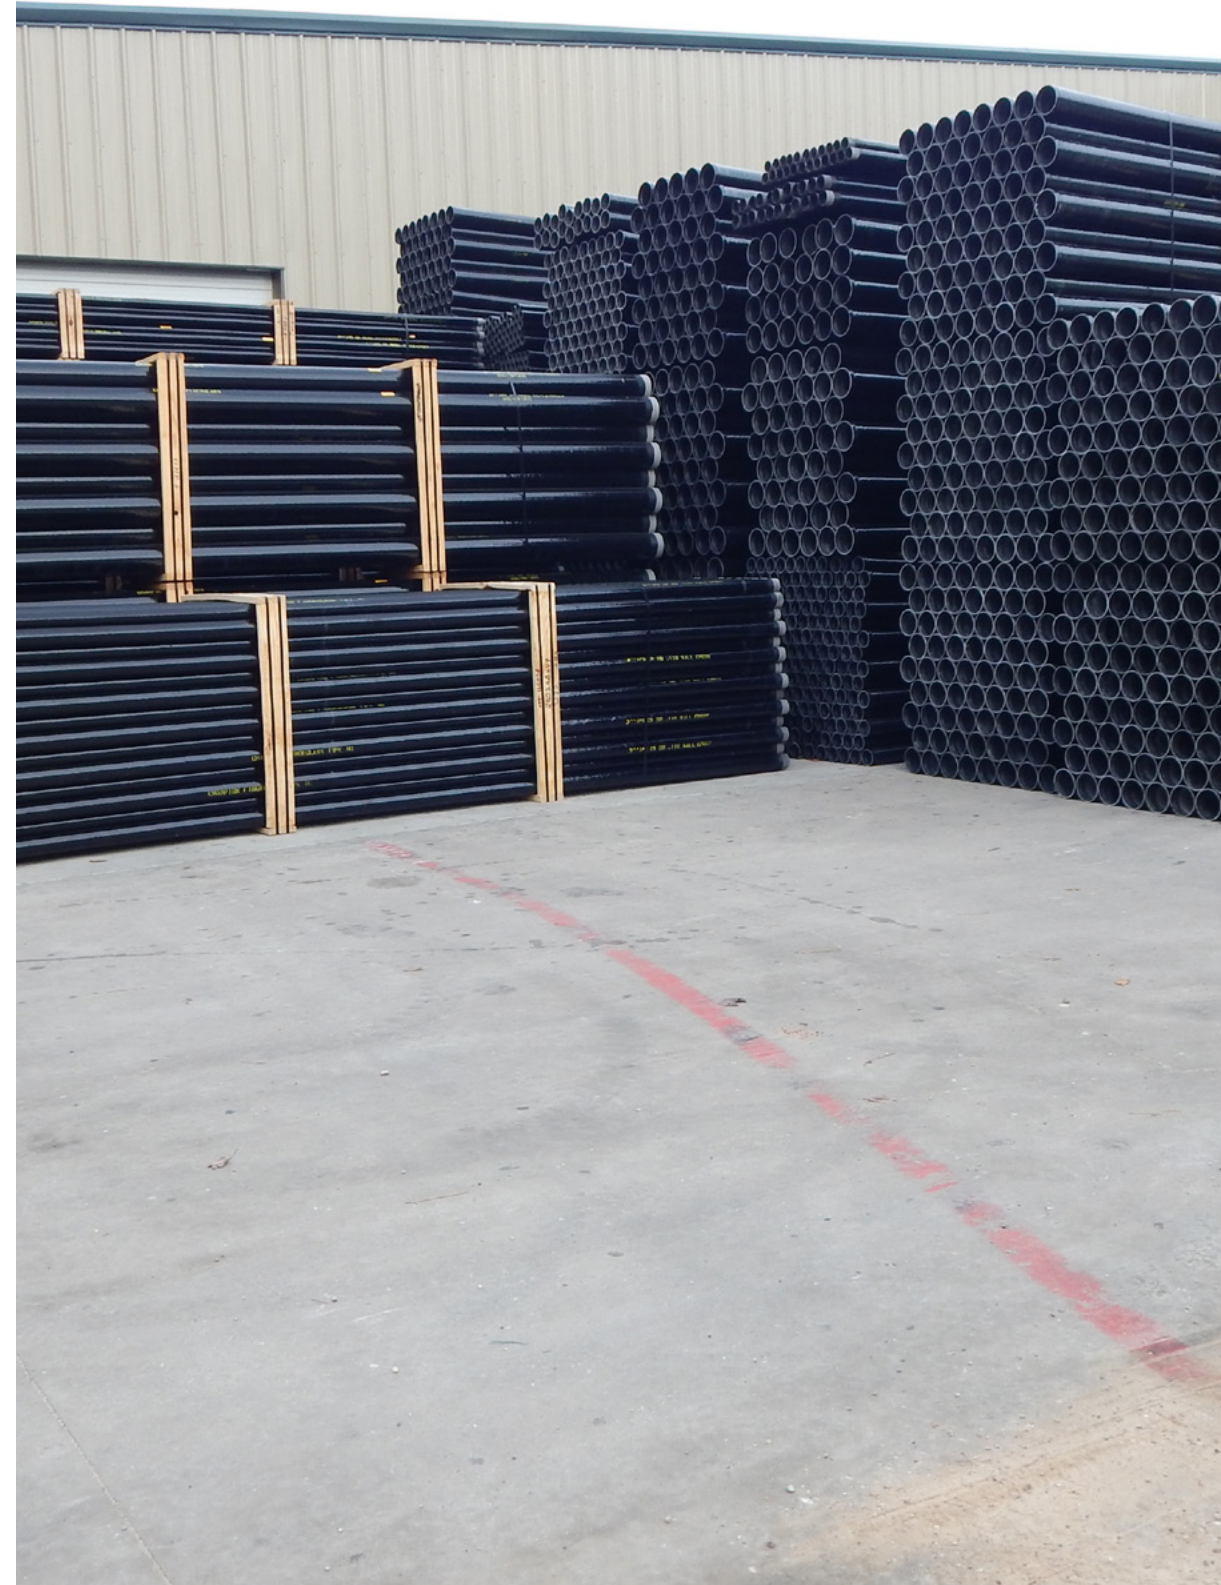
When it came time to install along the pier, workers on small rafts appreciated the lighter strut materials that were easy to handle and maneuver into place. Plus, Champion Strut proved easy to field cut and drill, facilitating a smoother, faster installation.

For this project, Champion Strut offered durable, corrosion-resistant framing and support for piping and conduit in a pier/coastal setting. As a composite material manufactured for stability, fiberglass strut is lightweight, strong, and engineered to handle loads and conditions found in caustic environments, such as wet, salty piers like those Reagan National Airport. Corrosion resistant to many chemicals, Champion Strut™ provided durability to withstand the briny nature of brackish salt water.
